A Case Study of the Failure on Apollo 13

Based on TMX-65270, Report of Apollo 13 Review Board

Prepared by Brenda Lindley Anderson, QD34

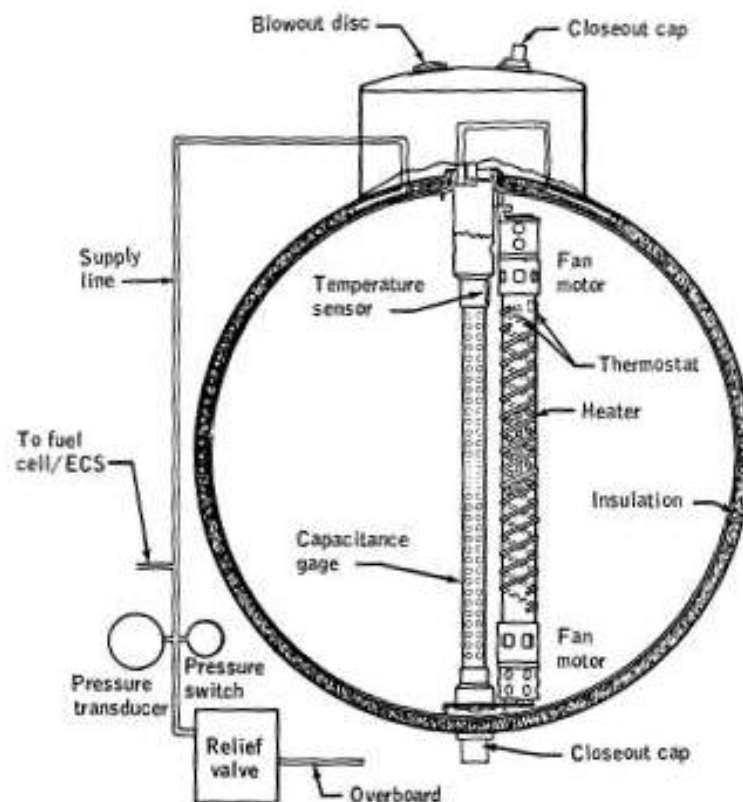
Figure 1 Service Module Oxygen Tank

The oxygen tank of the Apollo Service Module (SM) is constructed of concentric inner and outer shells, containing a vacuum between shells to reduce heat leak. A dome caps the tank providing containment for the fluid, electrical and signal paths into and out of the tank. See figure 1.

The gap between the tank shells also contains insulating material. Two tubular assemblies, the heater tube and the quantity probe, are located inside the tank. The heater tube assembly encloses two thermostatically protected heater coils, as well as two fans to stir oxygen in the tank, which is necessary in a zero gravity environment. The quantity probe assembly has a capacitance gauge in the lower half which electronically measures oxygen level in the tank. The probe consists of an inner cylinder to serve as fill and drain tube, and also as one plate of the capacitance gauge. On the upper half of the probe a temperature sensor is mounted near the head. Wiring for the assembly's electrical elements is routed out of the tank into the dome. There the wiring combines with a connector which links to circuitry to the command module (CM) and the service module (SM).

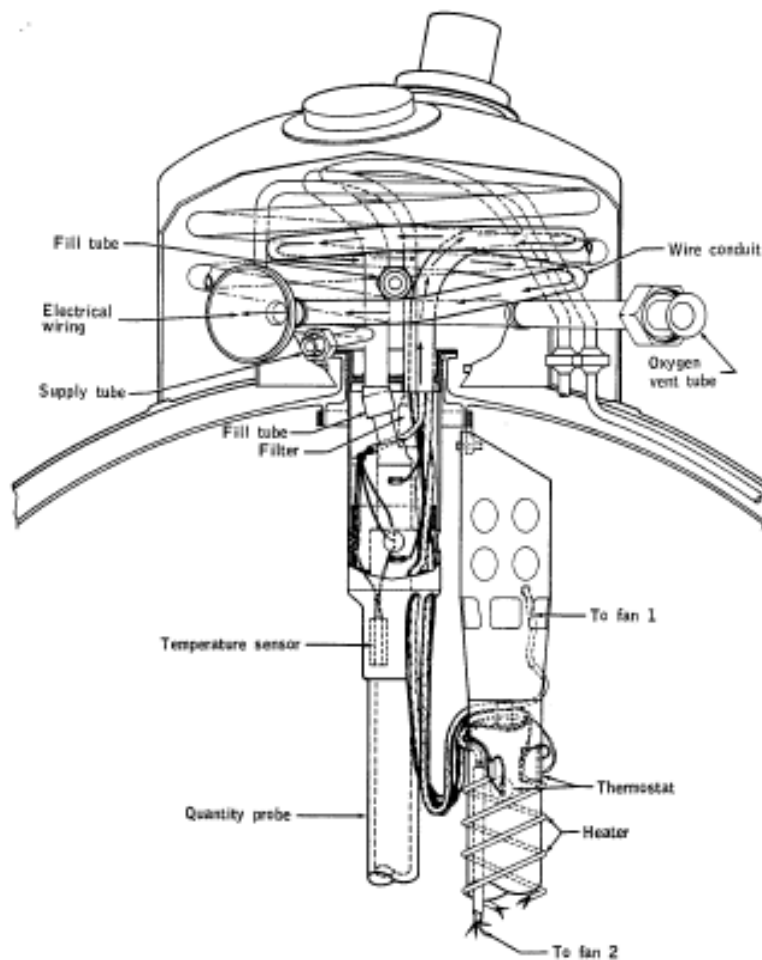
Figure 2 Wiring and Lines between Oxygen Tank and Dome

The routing of wiring and lines from the tank to the tank dome is shown in Figure 2.

was vented through the fill line. Now the quantity was 65%. Supplementary discussion among KSC, MSC, NA, and Beech personnel suggested that the de-tanking difficulty might be due to a leak in the line between quantity probe and fill line because of the loose fit between tube and sleeve. A leak in that line would allow gaseous oxygen to leak into the fill line, not driving lox from the tank. (Refer to Figure 2.) A discrepancy report was written for the oxygen subsystem.

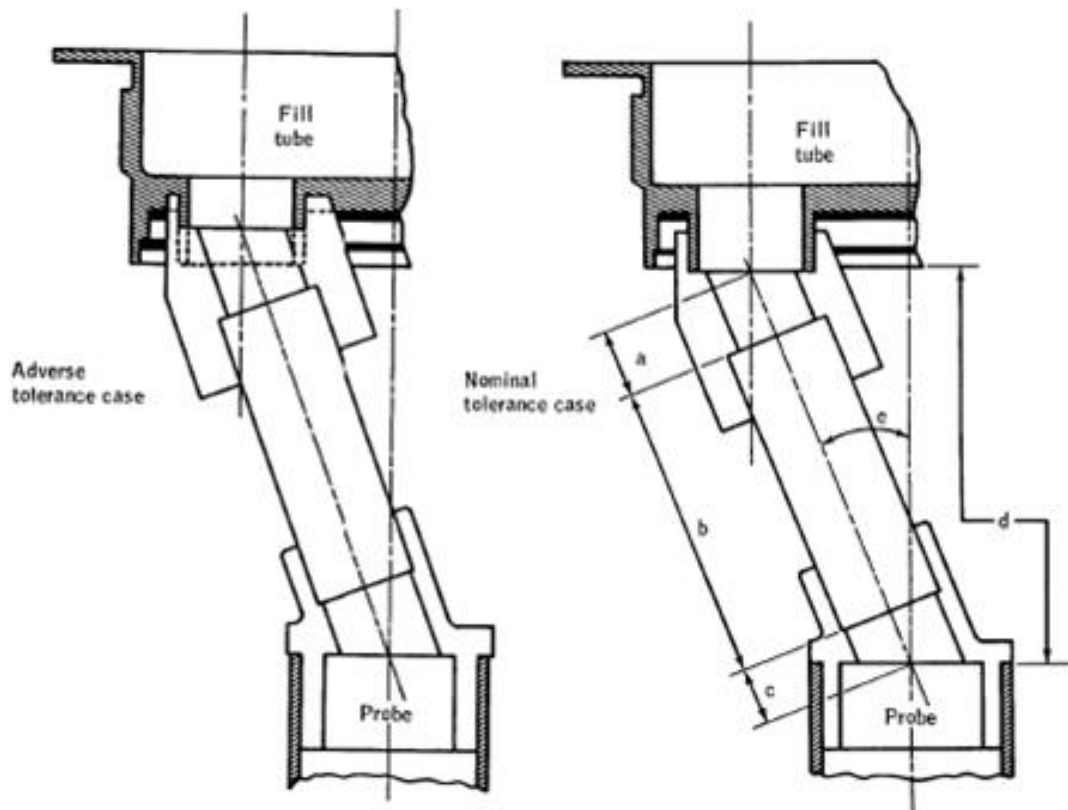
Figure 3 Nominal and Adverse Coupling Tolerance Cases

The fill line outside the oxygen tank enters, connecting to the inner cylinder of the capacitance gauge via a coupling comprised of Teflon adapters and Inconel tubing. The dimensions and tolerances for the assembly were chosen such that if worst case deviations occurred so the coupling didn't extend from fill line to gauge cylinder, a very loose fit would ensue. See Figure 3.

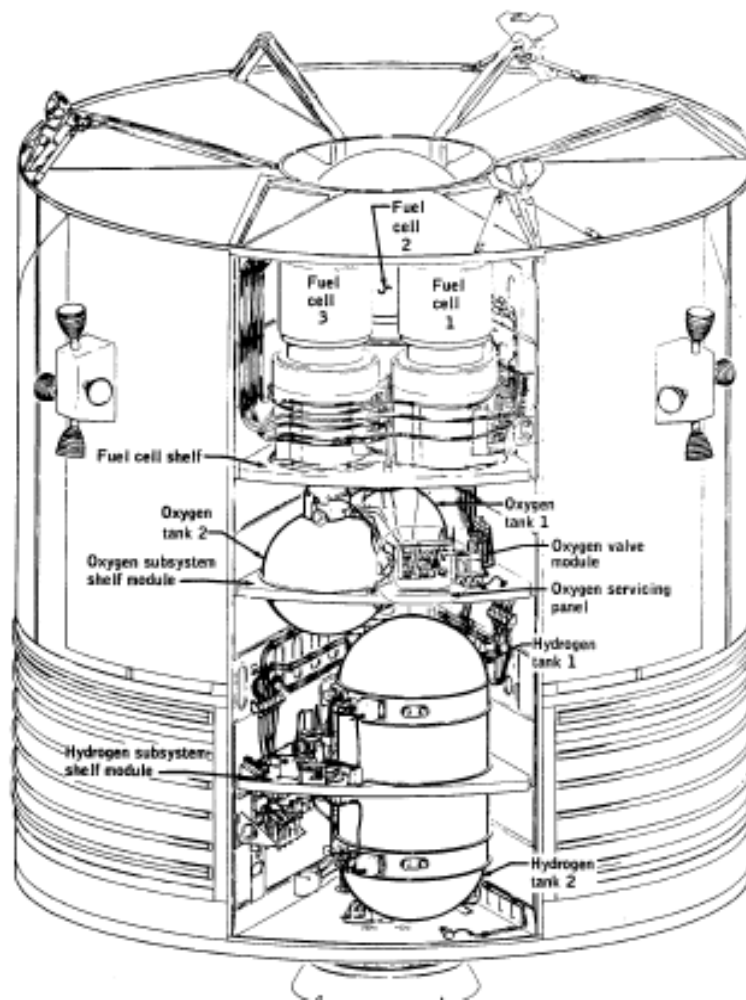
Figure 4 Arrangement of Cryogenic Systems and Fuel Cells in SM Bay 4

Oxygen tanks 1 and 2 are mounted on a shelf in bay 4 of the service module as show in Figure 4.

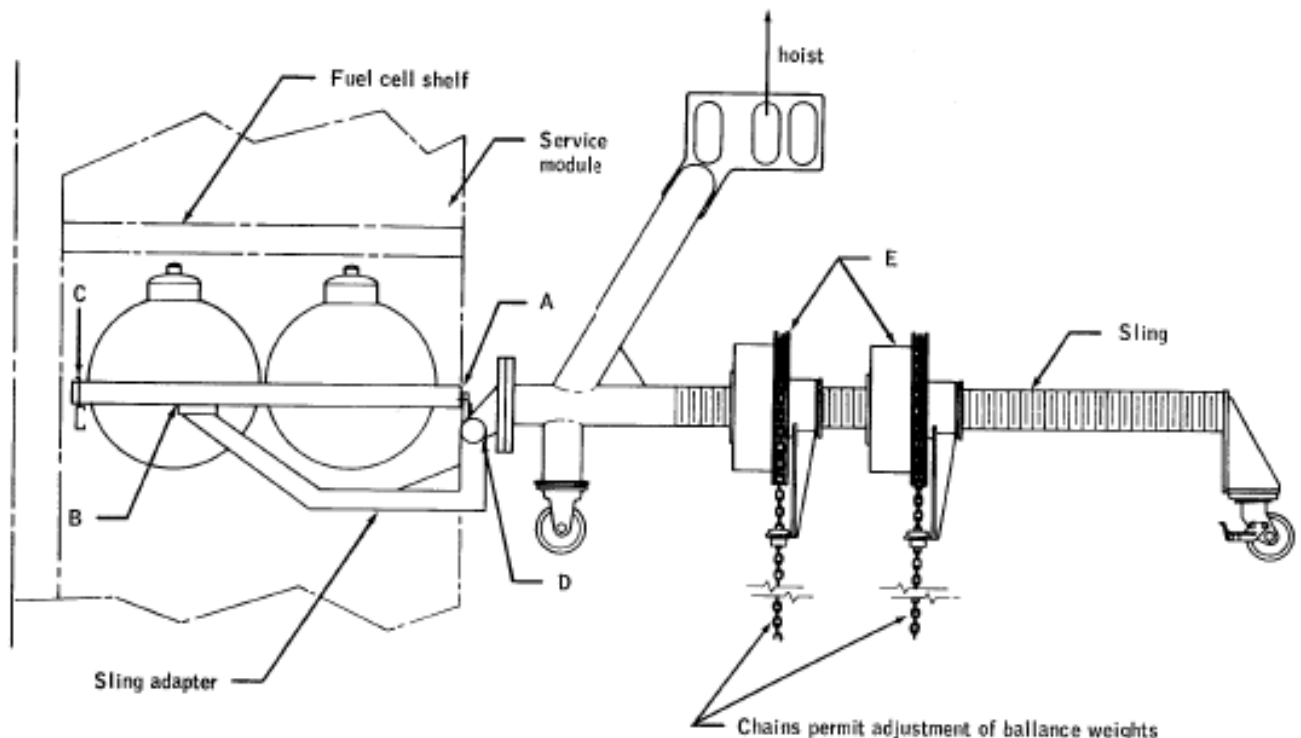
Figure 5 Hoist and Sling Arrangement for Shelf Assembly

The hoist and sling assembly shown in Figure 5 was used in removal of the oxygen shelf from SM 106. Disconnections were finished and a fitting from the crane was placed under the shelf to lift and remove it from the SM bay. A shelf bolt had been mistakenly left in the assembly. Consequently after the shelf was raised about two inches, the crane fixture broke and the shelf fell back into place. Photographs of the assembly following the mishap indicated that the close out cap of oxygen tank 2 might have struck the underneath side of the fuel cell shelf during the incident. At the time of the incident engineers thought that the shelf had simply dropped into place and they performed calculations to estimate the resultant force from the fall. After deliberation, the engineers decided that the shelf was initially accelerated upward before dropping which agreed with the photographic evidence.

The accident was recorded. The remaining bolt was removed and the shelf detached without additional problem. Because of this incident the oxygen shelf was re-tested for integrity, which including leak tests, proof-pressure test, and functional tests of pressure transducers, switches, thermal switches, and vacuum-ion pumps. No cryogenic testing was performed at this point. Additional visual inspection revealed no other problems. It should be noted that these tests would not have discovered any fill line leakage in oxygen tank 2. Additional tests and calculations performed during post-flight investigation concluded that the forces on the shelf during drop were likely close to those calculated at the time of the event. The investigating board determined the probability of tank damage from this accident was low, but it is possible that a loosely fitting fill tube might have become displaced by the drop.
